ANILOX ROLL QUALITY CONTROL REPORT

Roll Information, before cleaning.

Roll Information, after cleaning.

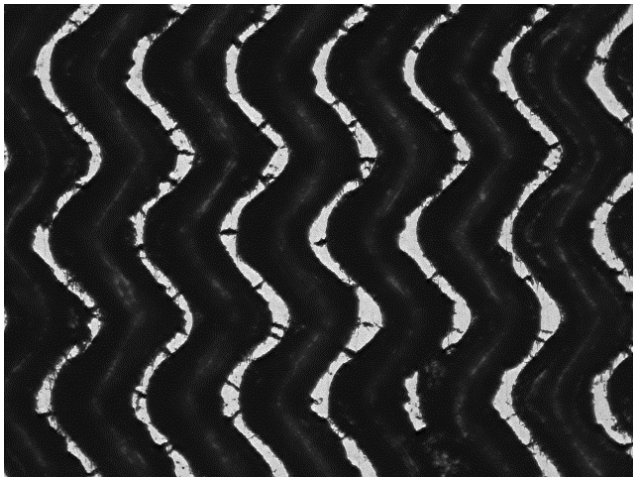
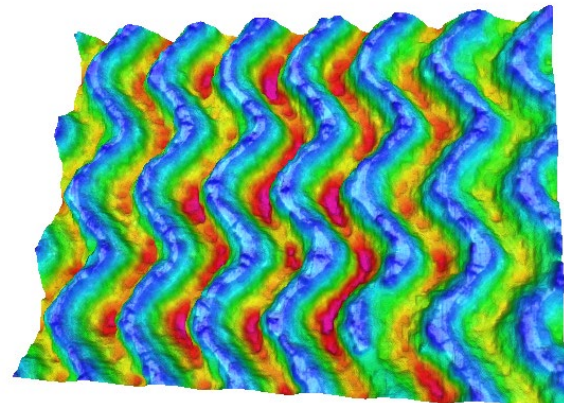
Cell Info: **Opening:** μm **Wall:** μm **Depth:** μm

↑
9.1 cm^3/m^2

Average Volume: 9.1 cm^3/m^2

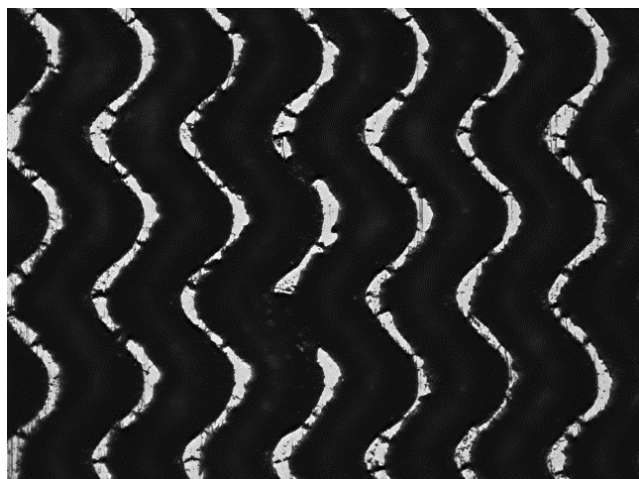
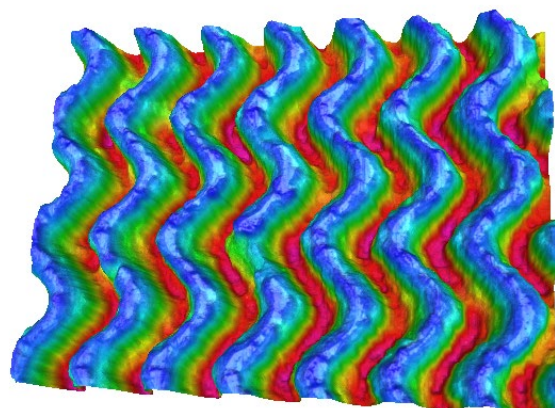
Cell Info: Opening: μm Wall: μm Depth: μm

↑
14.4 cm^3/m^2

Average Volume: 14.4 cm^3/m^2
(58.2%)

Advise for renewal months: < 3 < 6 12 > 12 no need

- Monitoring each month / Doctor Blade chamber check / Calcium treatment / Emergency kit
 Magnet and filter to prevent score lines / heating tank treatment / worn check by AniCAM
